Service and maintenance damage assessment of composite structures using various modes of infrared thermography

Abstract. Carbon Fibre Reinforced Polymers (CFRPs) have been widely used recently in aerospace technology as primary materials. During aircraft operation the combination of thermo-mechanical loads, gradually degrades the material properties. Therefore, the development of reliable and cost effective damage inspection protocols throughout the service life of these structures is of primary importance for their safe function. Within the scope of this study, Infrared Thermography (IrT) was employed with the aim of assessing the structural integrity of composite aero-structures in both maintenance (off-line) and service (on-line) conditions. In the maintenance concept, IrT was employed in Lock-in mode to evaluate artificially induced damage in bonded repaired materials. For this purpose, various configurations of damage were investigated. In the service concept, IrT was employed for the continuous monitoring of loaded repaired structures in order to assess in real-time any progressive evolution of de-bonding which could lead to failure of the bonded patch repair. The experiment

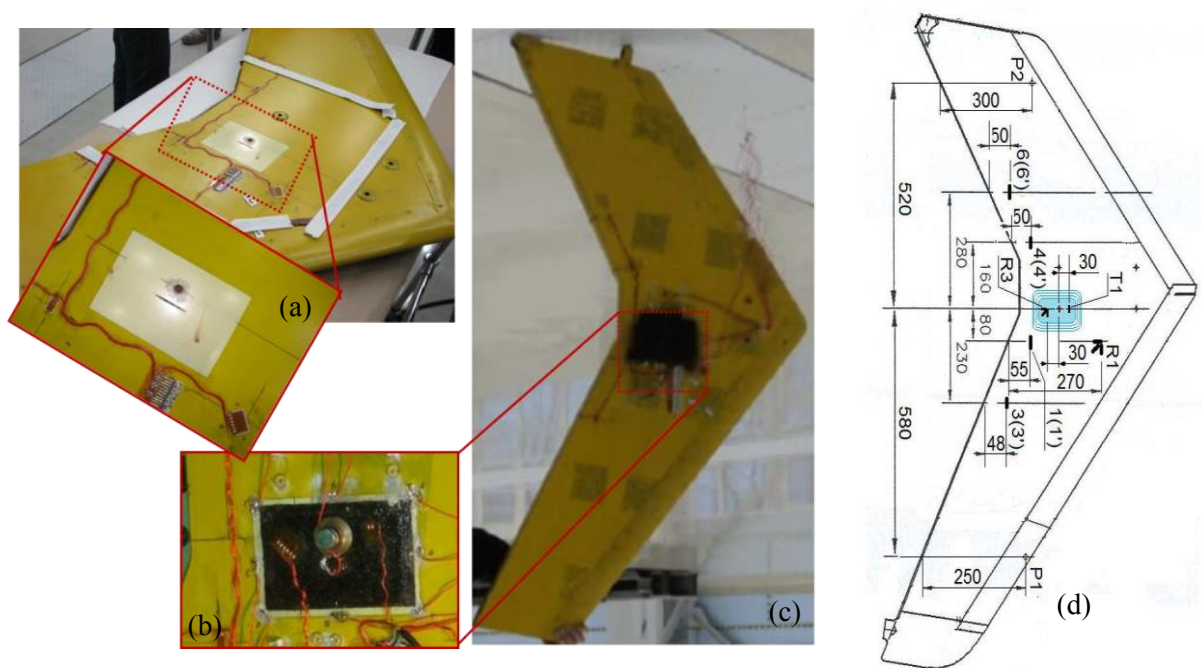
Figure 1. (a) Artificial crack (35mm), patched region, (b) applied bonded patch (80×120mm²), (c) SW 4 helicopter vertical stabilizer, (d) schematic representation of the stabilizer.

The structure of the stabilizer consisted of an internal core HexWeb CR III-3,8 5/32-10 (5052). The honeycomb thickness diverges from 32mm to 34.2mm. The aluminum skin was manufactured by the 2024 T3 alloy sheet. The thickness of the external surface varied from 0.4mm to 1.5mm. Figure 1 depicts the prepared for test stabilizer as well as a scheme with the dimensions of the wing structure.

In Figure 1b and 1c one can distinguish the applied bonded composite patch. The artificial crack is shown in Figure 1a. As can be seen, the crack was created close to the bolted joint. Figure 1d displays a schematic representation of the wing. For the requirements of the composite patch, the Hexcel 43280s series carbon fabric was adopted. As for the matrix, the Epocast 52 A/B was utilized.

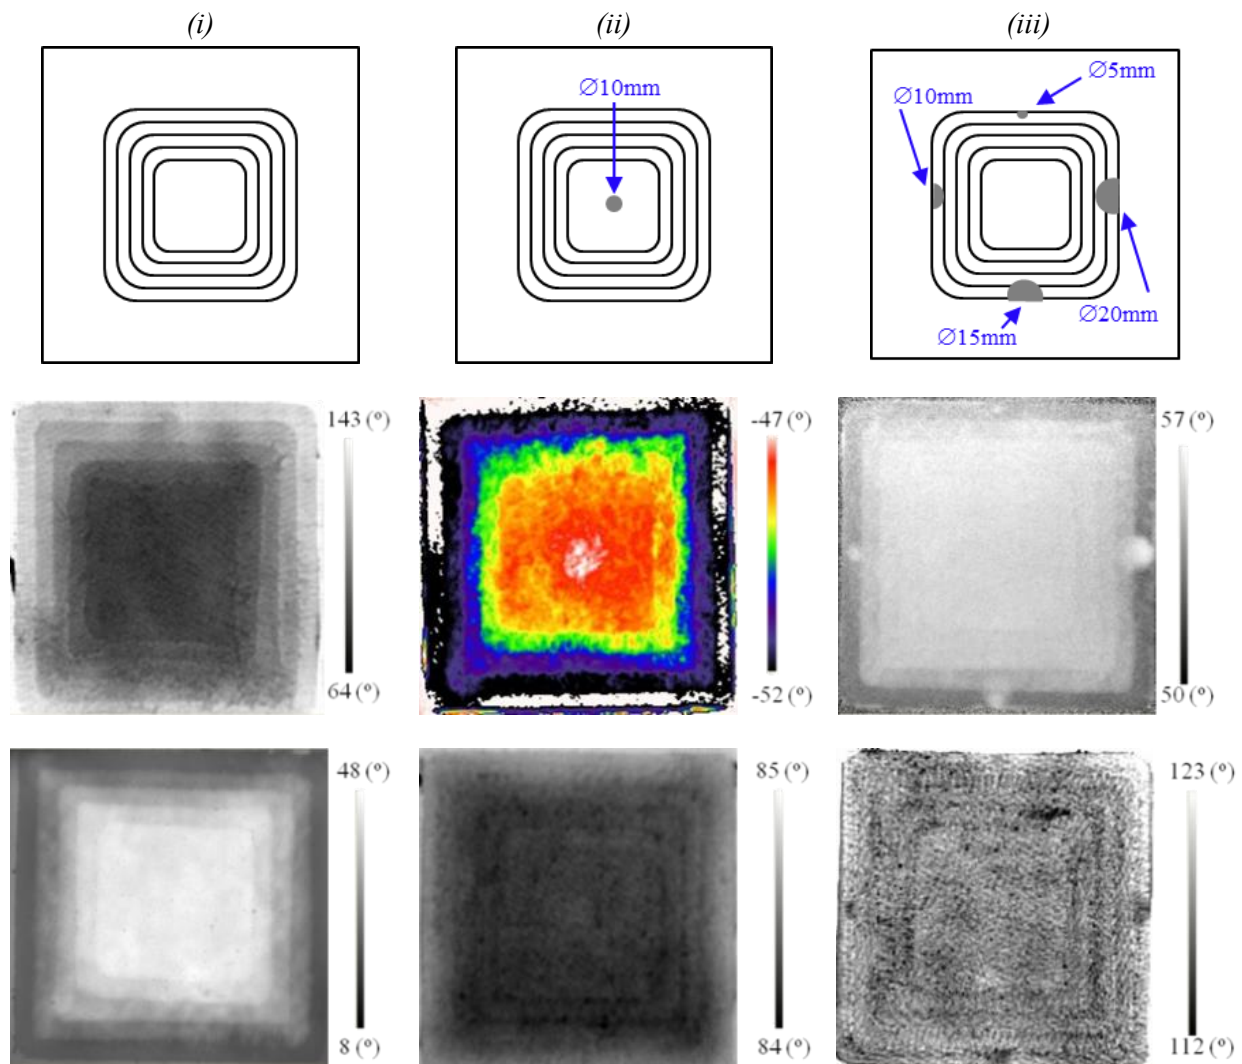
Figure 2a. (A) Coupon configuration, (B) Phase images by lock-in thermography; Al substrate, (C) Phase images by lock-in thermography; Composite substrate, (i) No defect, (ii) Central patch substrate de-bonding, (iii) Patch substrate de-bonding.

Figures 2a (i-iii) and 2b (iv-vi) depict the thermographic images derived when scanning the repaired plates with LT. Grey and yellow coloured shapes on the coupon configuration schematics represent the location and shape of the artificially induced damages. The thermographic experimental parameters are listed in Table 1.

As is obvious from Figures 2a and 2b, all interrogated artificial defects were detected. In Figure 2a (i) the undamaged reference specimen is depicted. Figure 2a (ii) shows the inserted teflon defect in the centre of the repaired plate. In the case of Al substrate, damage is easier witnessed when using the colorful palette. In Figure 2a (iii) all artificial PTFE flakes between the patch and the mother structure are visible. In Figure 2b (iv) the induced damage between the layers of the patch can be readily discerned. A surface defect visible to naked eye is also identified. In Figure 2b (v) the triangular Teflon insert is easily unscrambled. Figure 2b (vi) depicts the 50% simulated bad adhesion. In this damage configuration thermography was not as successful as for the rest. For this damage concept, oil grease was employed to provoke “bad” adhesion. The thermographs indicate that “bad” adhesion was not traceable. On the contrary it is possible that the majority of the patch/substrate interface remained intact. Poor adhesion is manifested as fade bright areas in the middle of both repaired substrates. In all phase images above the different layers of the patch are visible. Moreover, high consolidation

degree of the manufactured patches was observed. It is noteworthy that the thickness of the Teflon defects was equal to 50 μm , lower than in other studies [6]. Although their detection was feasible, reduced thickness additionally hampered the discerning efficiency of the artificial defects.

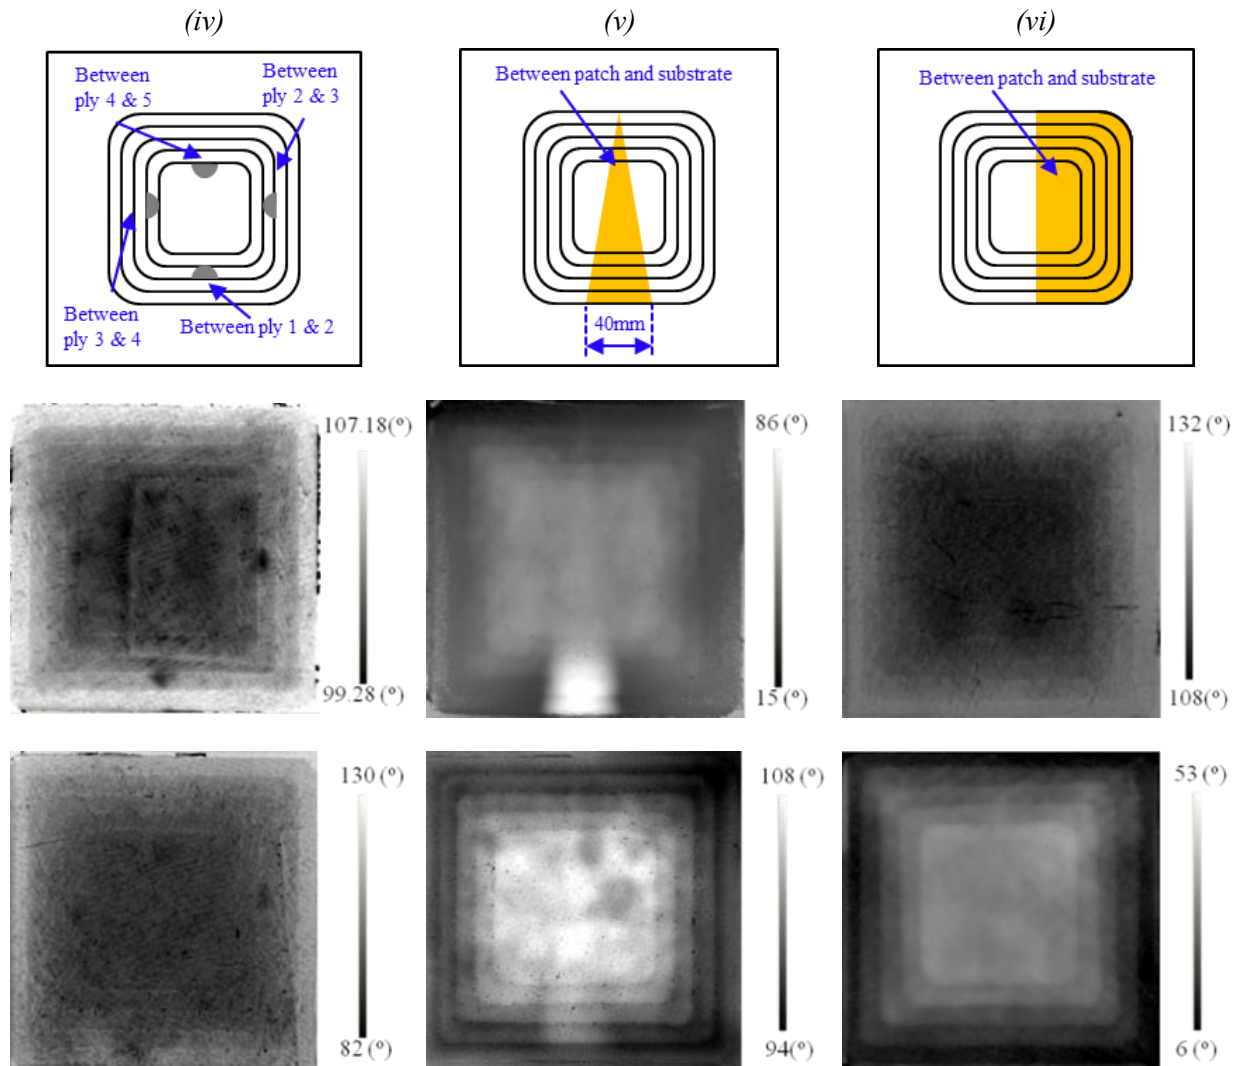
Figure 2b. (A) Coupon configuration, (B) Phase images by lock-in thermography; Al substrate, (C) Phase images by lock-in thermography; Composite substrate, (iv) Delamination between patch layers, (v) Triangle de-bonding, (vi) 50% bad adhesion.

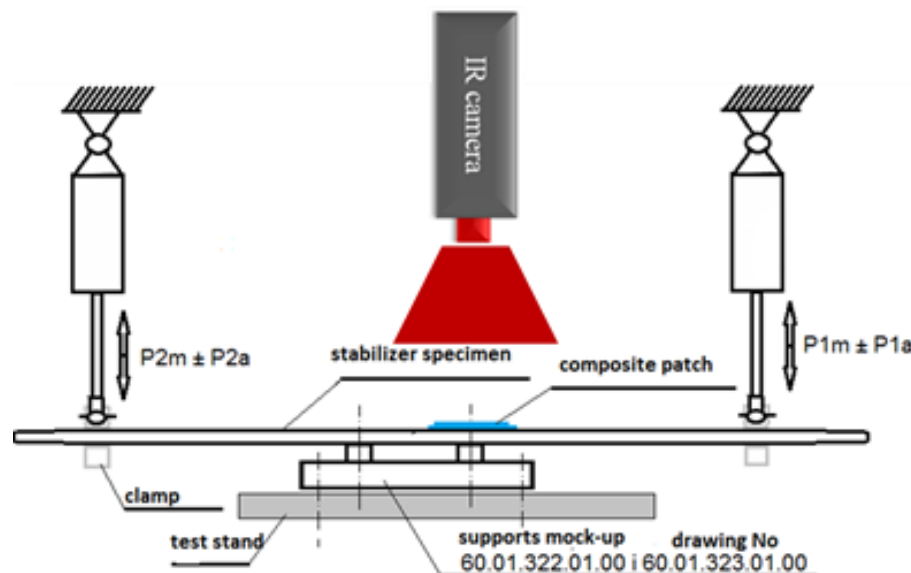
Figure 3. Experimental setup.

In Figure 3 the testing configuration is depicted. The induced bending moments were in different amplitude in order to equilibrate the distance difference between the centre and the clamped points. The structure was tested in 20Hz cyclic bending fatigue. The infrared camera was synchronized with the frequency of the testing machine providing both amplitude and phase images. The infrared sensor was appropriately positioned vertically-faced above the repaired side of the stabilizer (Figure 3). The distance between the camera and the stabilizer was approximately 0.8m. Having two signal outputs from the controller, the camera was connected with the P1 loading moment. The frame rate of the infrared camera was set to capture four images per loading cycle.
